Summary Report  
Soil and Groundwater Sampling  
Henkel Surface Technologies Facility  
Morenci, Michigan  
MID 058 723 867

October 30, 2002

SUBJECT: Summary Report  
Supplemental Investigation to Address USEPA Concerns  
Former Morenci Facility  
Morenci, Michigan  
Project #1004-05

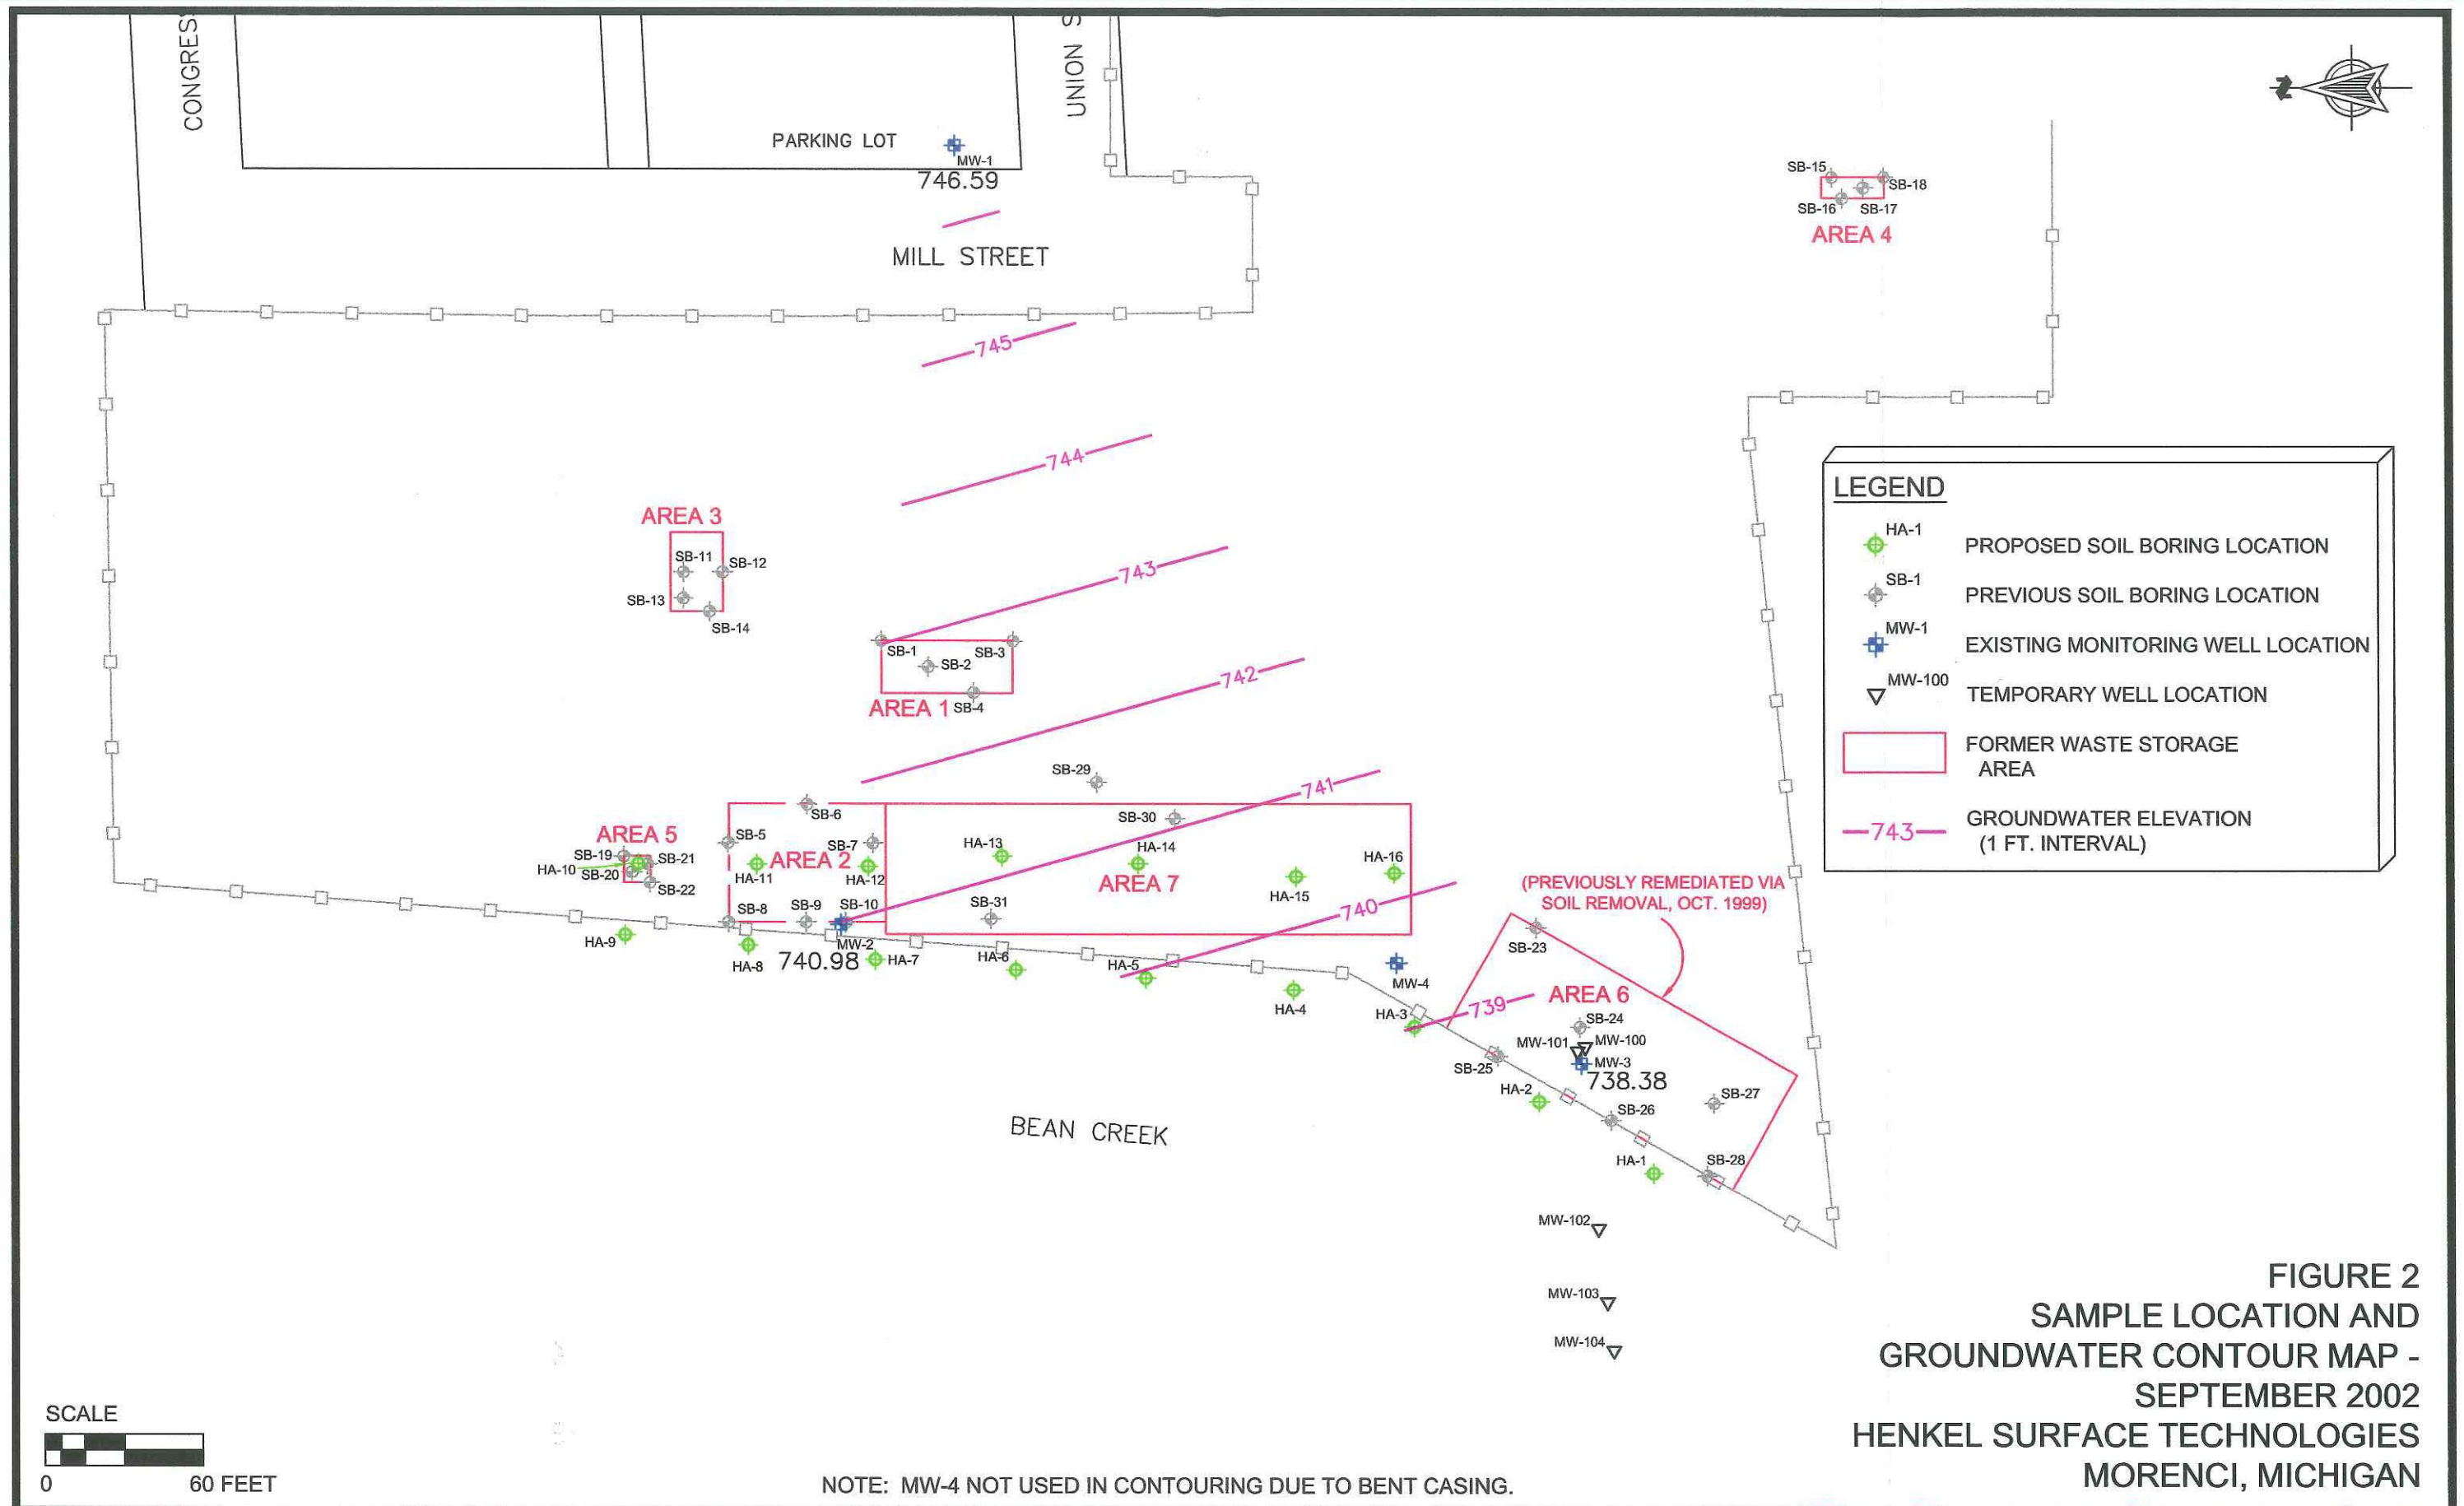
Third, the groundwater flow direction at the Site was determined using the groundwater elevations determined at monitoring wells MW-1, MW-2, and MW-3 (Table 2 and Figure 2). Then three short-screen drive point piezometers (MW-102, MW-103, and MW-104) were driven into the permeable soils in a line across Bean Creek in the approximate direction of groundwater flow from the Site. These piezometers were installed during a low-flow period when the water in the creek was predominantly due to groundwater discharge and surface runoff was minimal.

Soil Sampling: The Dragun Corporation installed 16 soil borings with a stainless-steel hand scoop (HA-1 through HA-16) to depths of approximately one fbg1 (refer to Figure 2). Soil samples were field-screened with a photoionization detector (PID) to determine the presence of organic vapors. No PID readings were detected at any of the sample locations.

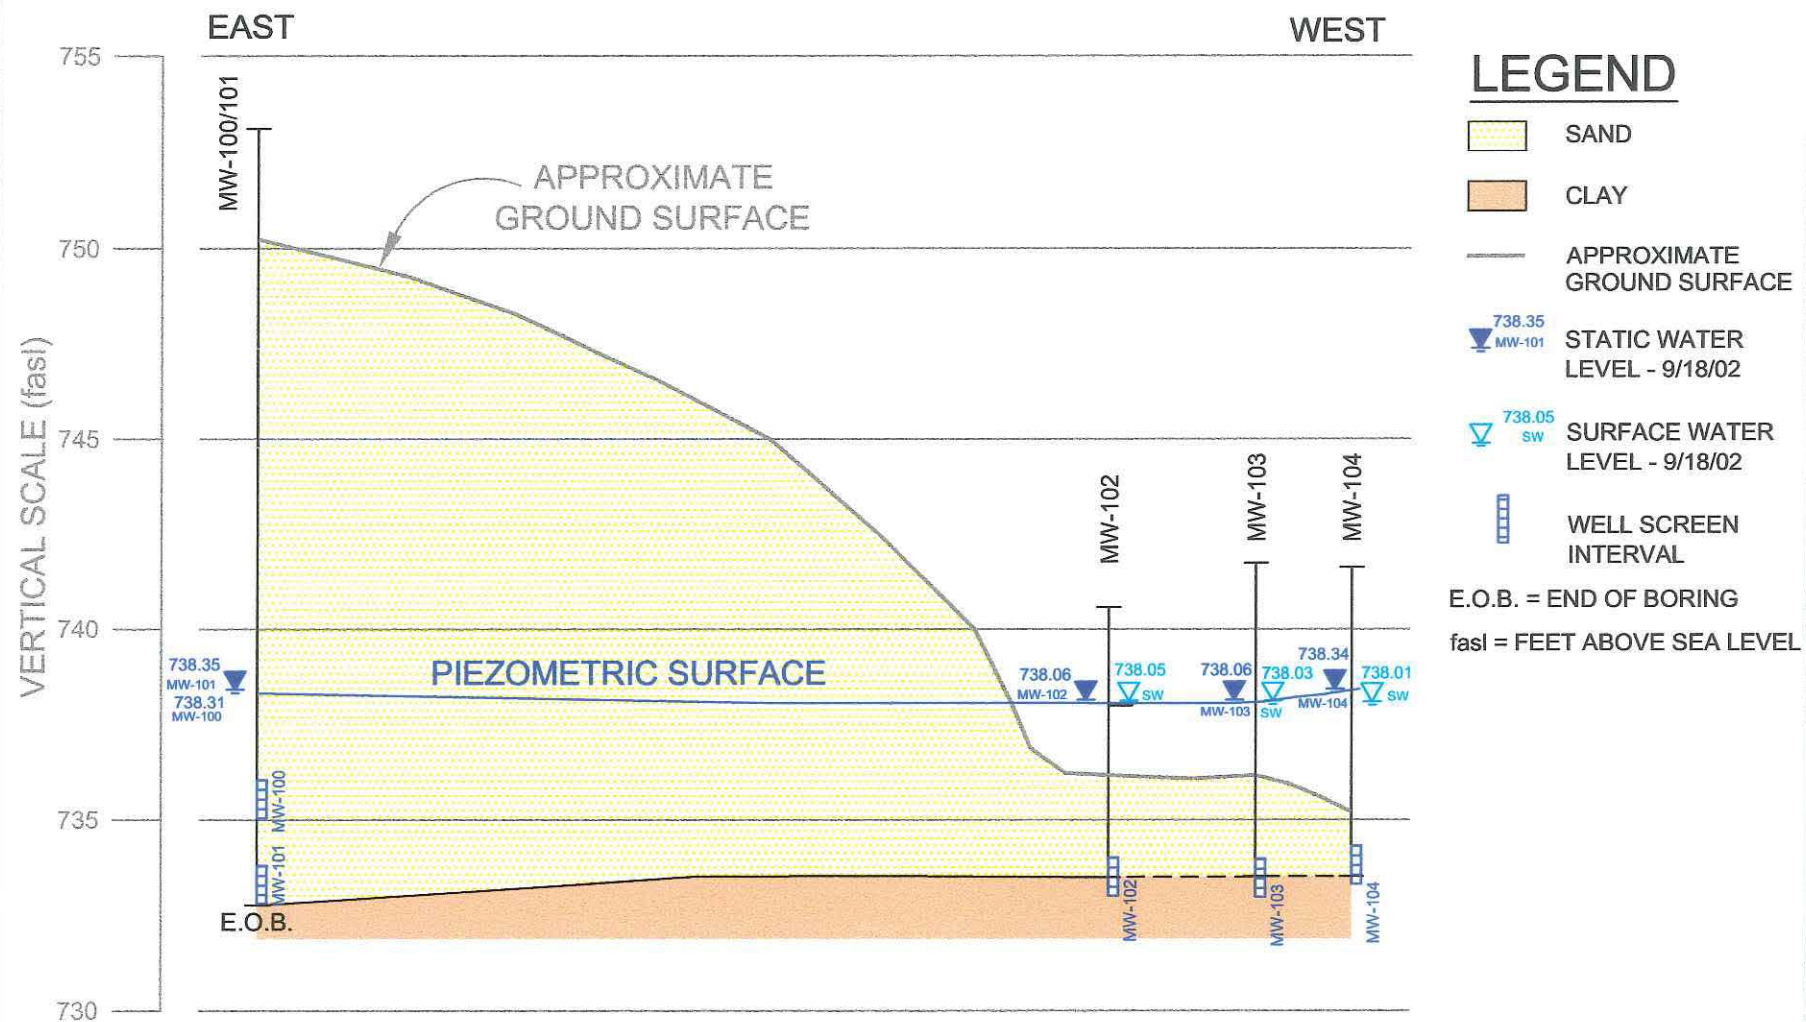
**FIGURE 3**  
**HYDROSTRATIGRAPHIC CONDITIONS NEAR BEAN CREEK**  
**HENKEL SURFACE TECHNOLOGIES**  
**MORENCI, MICHIGAN**

Finally, monitoring wells MW-101, MW-102, MW-103, and MW-104 are screened at the base of the water bearing zone, the latter three in Bean Creek (Figure 3). Table 1 and Figure 3 show that groundwater elevations at MW-101 and MW-104 are higher than the groundwater elevations at

MW-102 and MW-103, which are screened below Bean Creek. This means that groundwater discharges into Bean Creek from both sides of the stream, which in turn means that groundwater cannot underflow Bean Creek.
